YPG REPORT NO. 6043

ENGINEERING/SERVICE DESERT ENVIRONMENTAL TEST OF
FOXHOLE DIGGING AID (INTERIM)

WALTER E. SCHOUDEL, SP5
SCIENTIFIC AND ENGINEERING
NOVEMBER 1966

YUMA PROVING GROUND
YUMA, ARIZONA

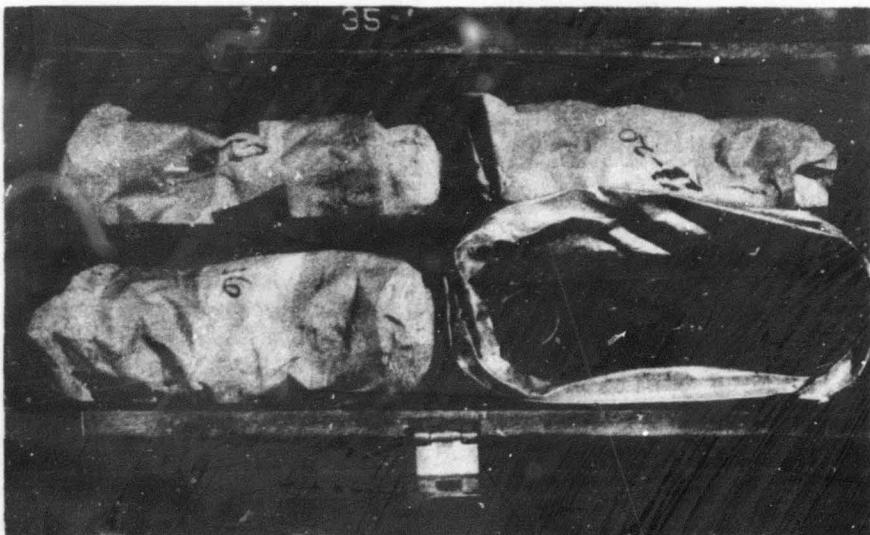
FIGURE 6. Test items as packed for airdrop. The container of 40 units included five test items and 35 simulated items. Note pipe utilized to simulate test items.

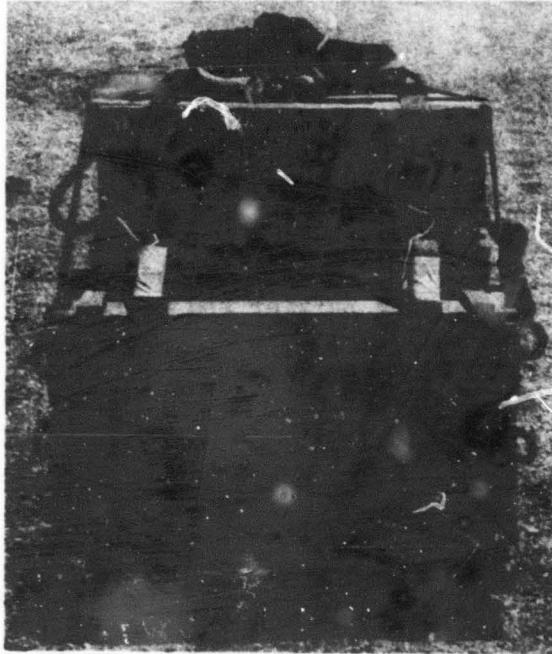
FIGURE 9. Before air drop No. 3 (intentional malfunction). Note position of package rigged on its side such that the test items are in a horizontal attitude.

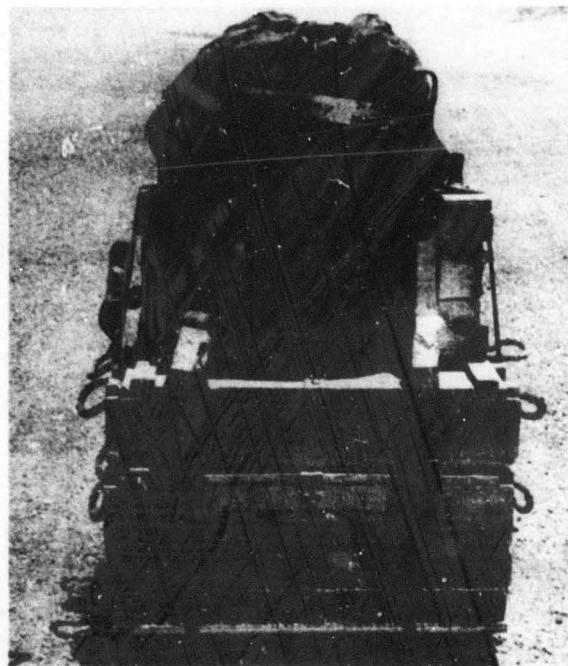
FIGURE 8. Before air drop No. 2 (intentional malfunction). Note position of package rigged on its side such that the test items are in a horizontal attitude.

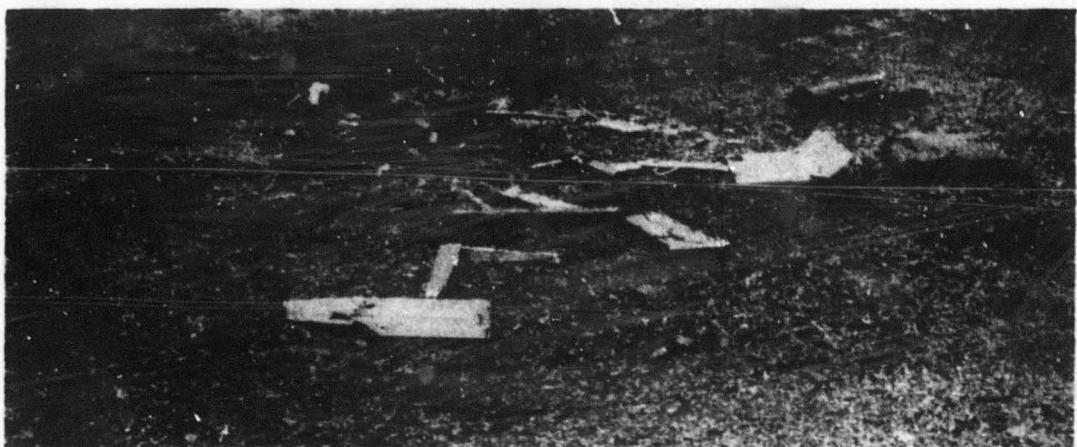
On air drops no. 2 and 3 and test items remained intact (Table 5, App I and Fig. 11 and 12, App III). No exposed propellant was visible. No detonation or fire occurred. The test items were disposed of in place.

FIGURE 11. After air drop No. 2 (intentional malfunction).

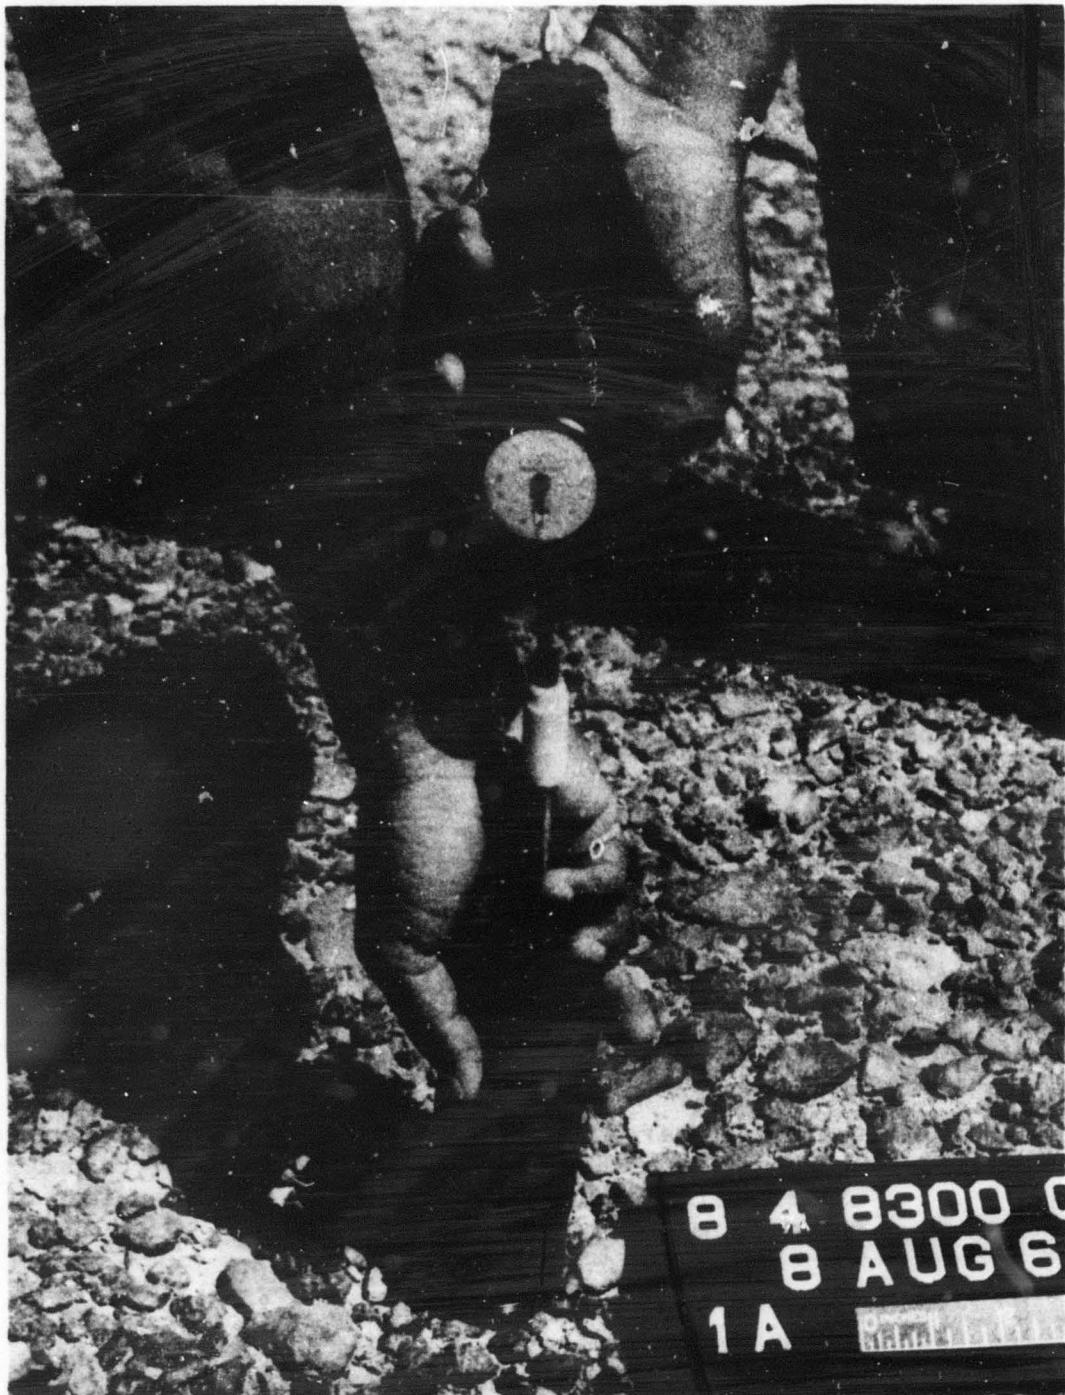
e. Personnel can exert sufficient hand force to initiate the explosive even though the average force of 17 pounds does exceed the QMR requirements.

The force required to depress the activator button was measured with a mechanical force gage at various times during the final phase of the test (Fig. 13, App III). Data including appropriate comments by operating personnel were noted (Tables 4 and 5, App I).

FIGURE 13. Mechanical force gage used to measure initiation load.

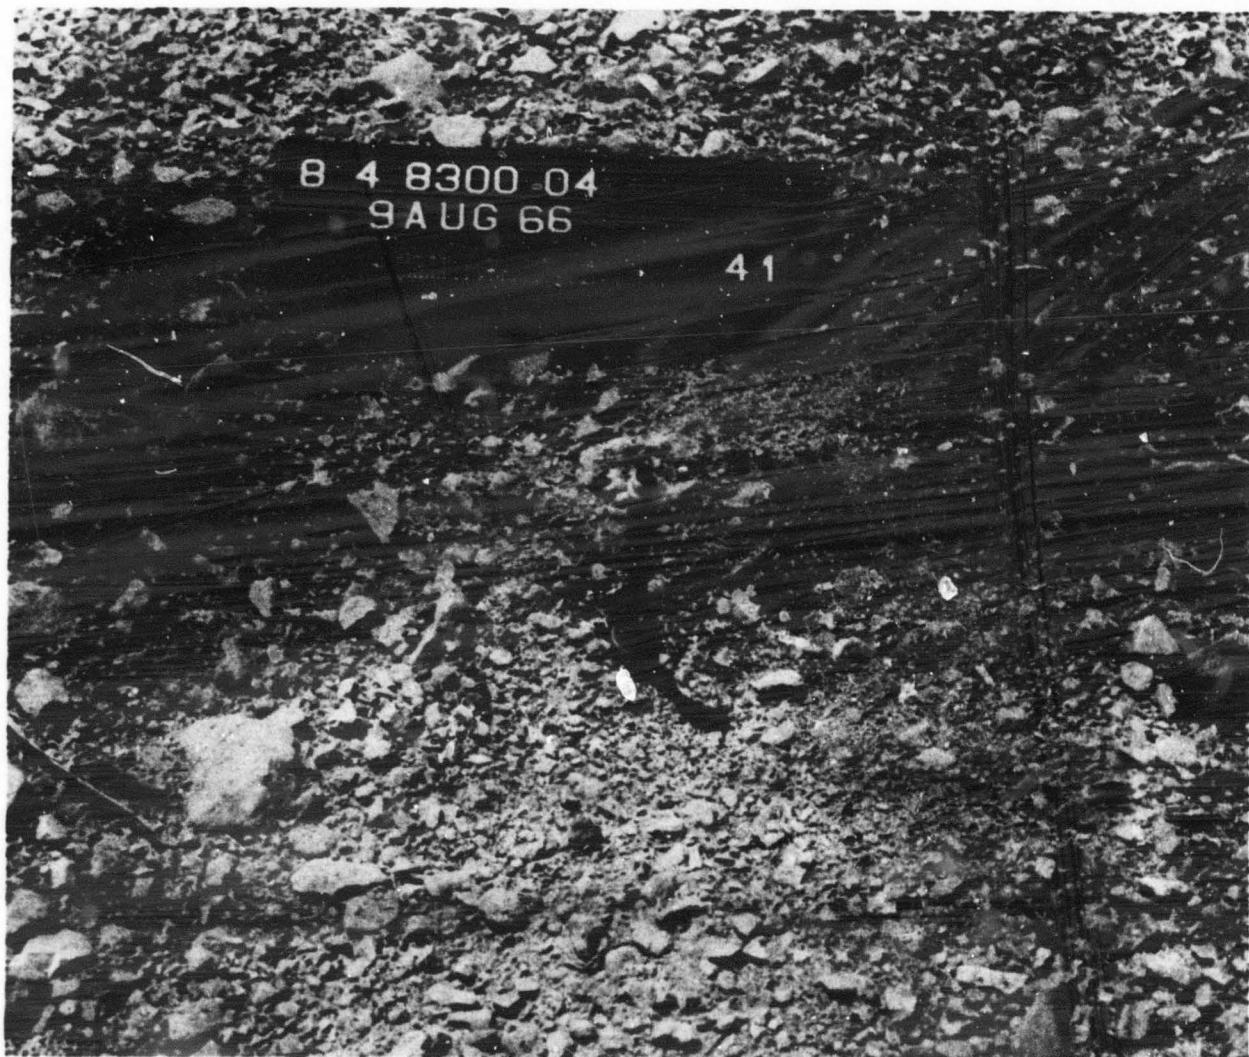
FIGURE 14. Cratering charge emplaced at base of original excavation. Note portion of charge above ground surface. Second cratering charge utilized to enlarge the dimensions of the original excavation.

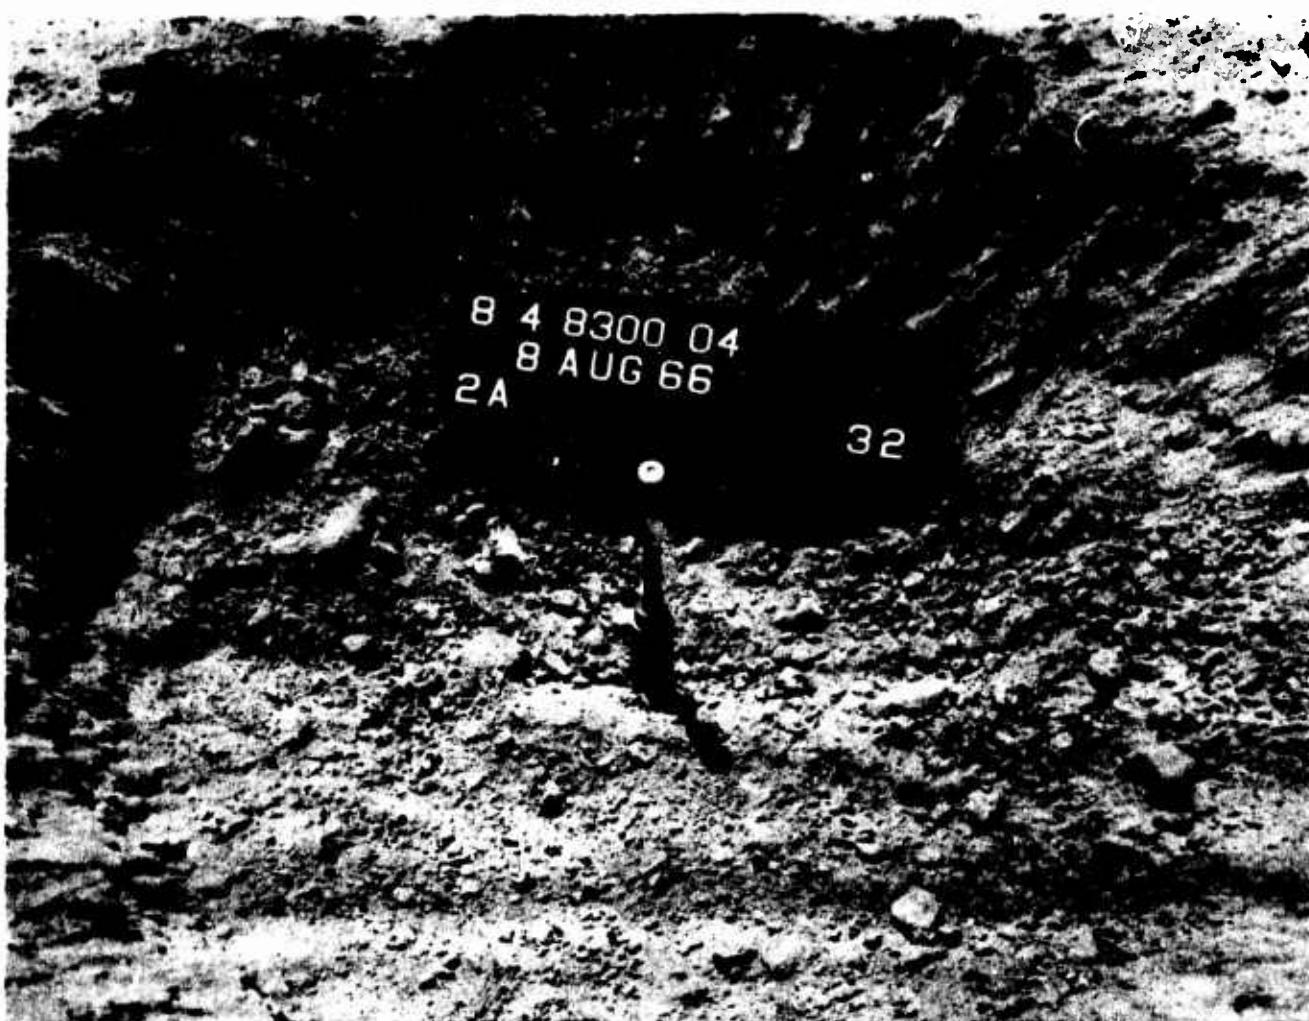
i. The shaped charge did not consistently generate an effective pilot hole and the operator frequently experienced difficulty inserting the cratering charge because the hole lacked sufficient depth or a cave-in occurred (Para. 2.6.3 and 2.6.4).

FIGURE 16. A typical cratering charge emplaced and ready to fire. Note ineffective pilot hole formation. Charge must be forced into hole and a portion remains above the ground surface.

d. That the cratering charge be tapered in order that it might be inserted into the pilot hole more easily.

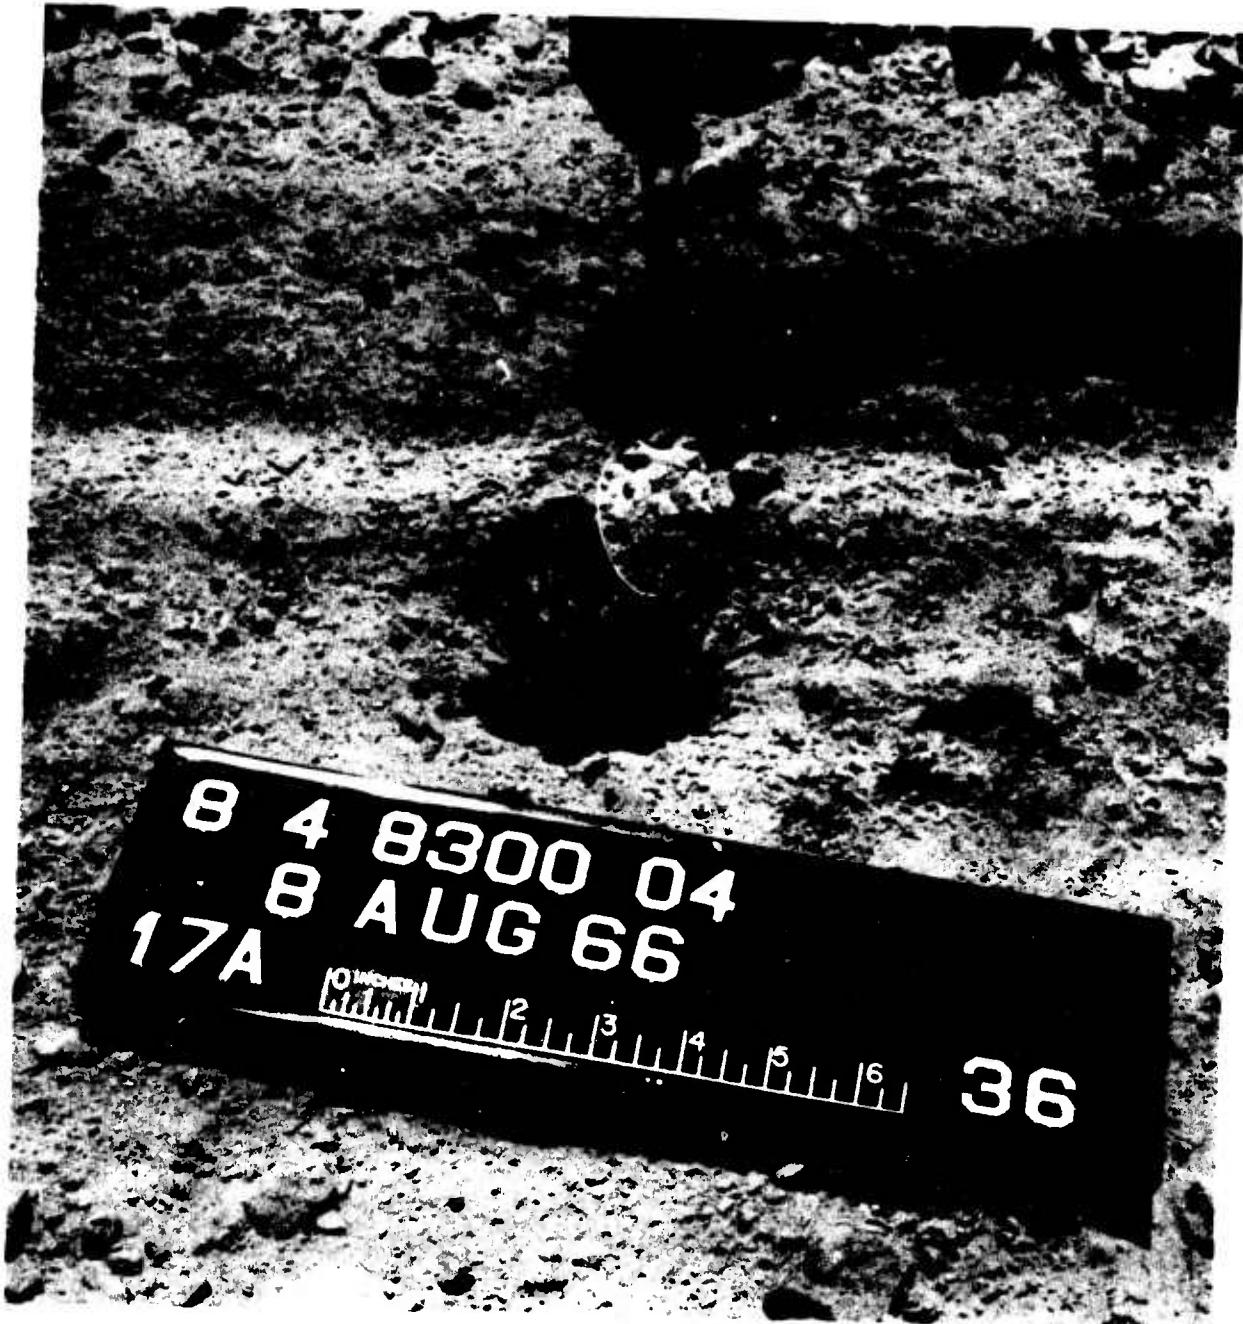
All dimensional requirements were met when two foxhole digging aids were utilized to generate the excavation (Table 5, App I). The shaped charge generally did not produce useful or well defined pilot holes when used on the ground surface in the conventional manner. When emplaced at the base of the original hole during the secondary phase of excavation it displayed even poorer performance (Fig. 15, App III). Usually the operator had to force the cratering charge into the pilot hole and frequently a portion was above the ground surface (Fig. 16 App III). Frequently the operator experienced difficulty emplacing this charge due to the fact that the charge has a blunt end (see Frontispiece). A spoon or rod provided only limited assistance in emplacing the cratering charge or improving the dimensions or definition of the pilot hole (Fig. 17, App III). Four duds (4.9 per cent) occurred during the test (Table 6, App I).

FIGURE 17. kit spoon used to assist in forming pilot hole.
